From: Jackson, Thomas [thomas.jackson@bakerbotts.com]
Sent: 12/29/2020 9:57:08 PM
To: Talton, Chuck [talton.chuck@epa.gov]
CC: Costello, James [costello.james@epa.gov]; Miller, Matthew [Miller.Matthew@epa.gov]; Williams, Paulina [paulina.williams@bakerbotts.com]; Henderson, Bryan [Bryan.Henderson@BakerBotts.com]
Subject: Globe-Union Site - Section 104(e) information request

Decontamination and Site Remediation Summary

***Johnson Controls
Battery Group, Inc.***

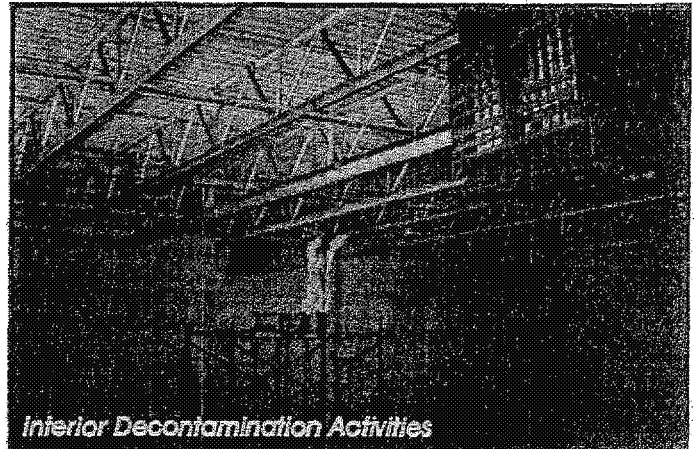
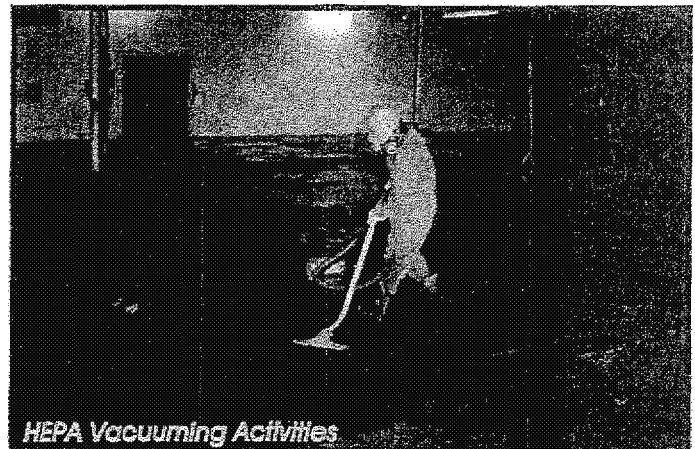
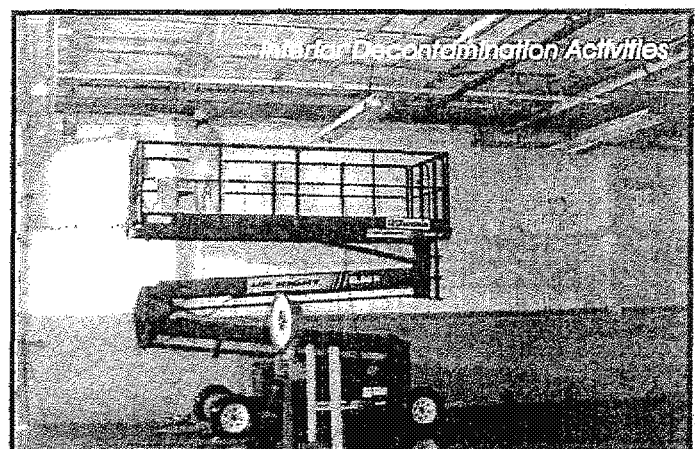
Decontamination activities included the use of hydro-blasting units, hand held jack hammers, HEPA vacuums, lifts, and various small tools for specific area needs.

- 1.) Removal and containerization of loose debris from area.
- 2.) HEPA vacuuming loose residual.
- 3.) Chipping and stripping secured residual deposits.
- 4.) Hydro-blasting surfaces.
- 5.) Collection of decontamination water.
- 6.) Wet-Vac of residual decontamination water.
- 7.) Verification sampling.

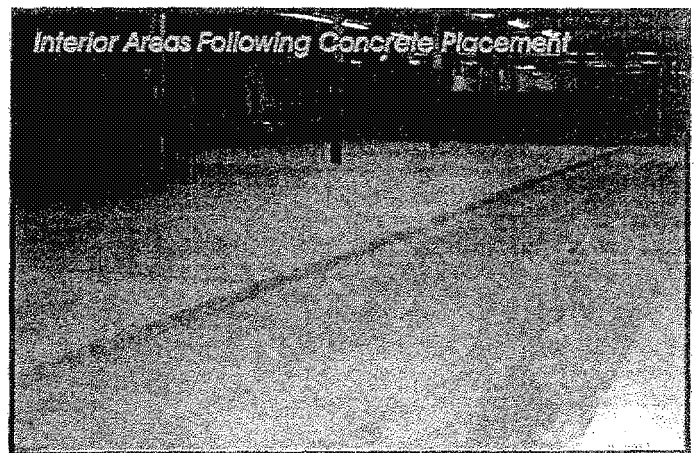
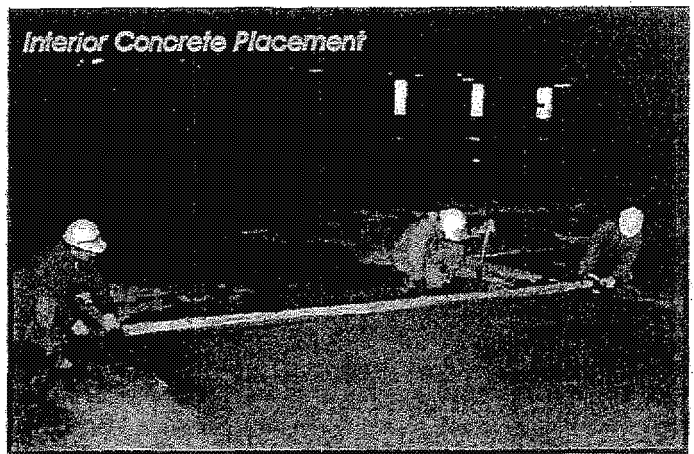
A deteriorated portion of concrete near the lab area was removed and then replaced with new concrete. Demolished concrete was transported to Big City Concrete. Following removal of the deteriorated concrete, a sand layer was placed and cement cap was poured. The new concrete was leveled to the existing surrounding grade.

Following completion of cement curing, a floor coating was added to the surface.

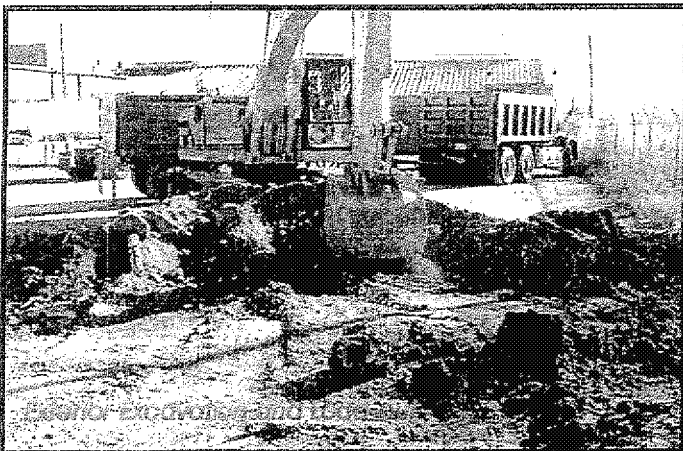
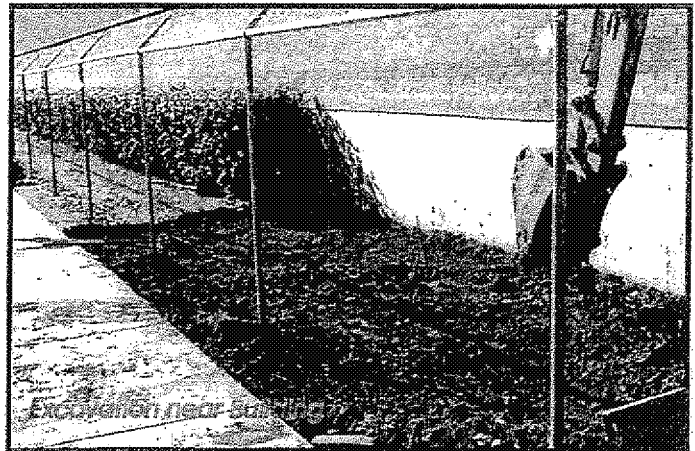
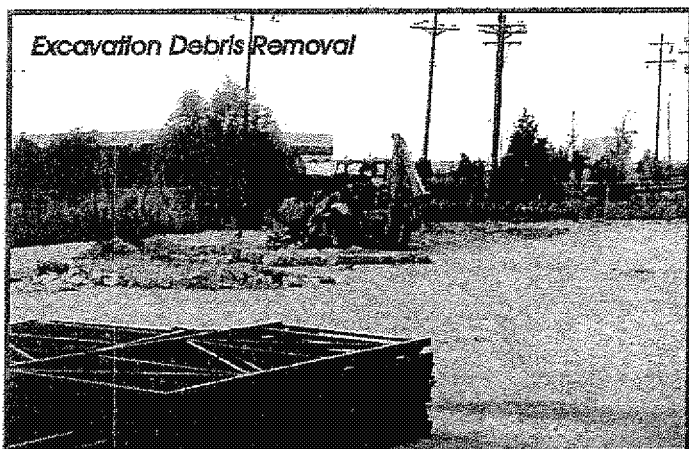
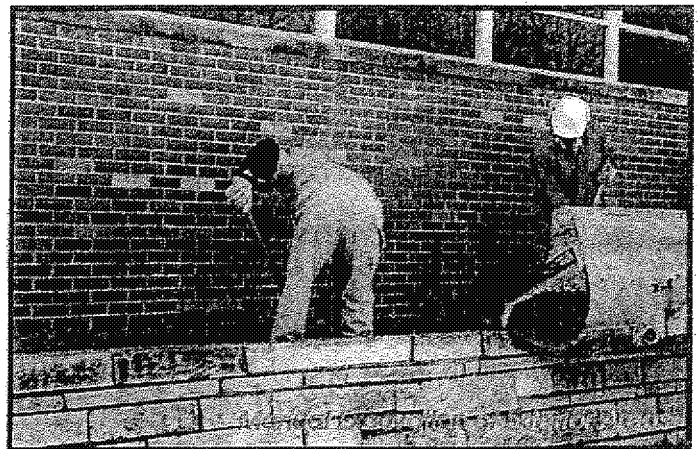
Lead affected soils above the clean-up criteria were excavated and transferred to either the soil treatment area for stabilization or a staging area for future transportation and disposal.

Soil exhibiting hazardous characteristics (TCLP lead levels above 5.0 mg/L) or Texas Class I characteristics (TCLP less than 5.0 mg/L but greater than 1.5 mg/L) was transferred to the stabilization equipment and processed.

The lead impacted soil was mixed in a container with Phosphate-based additives. The additive bonded with the lead molecules and rendered it non-hazardous by limiting the lead's ability to leach.

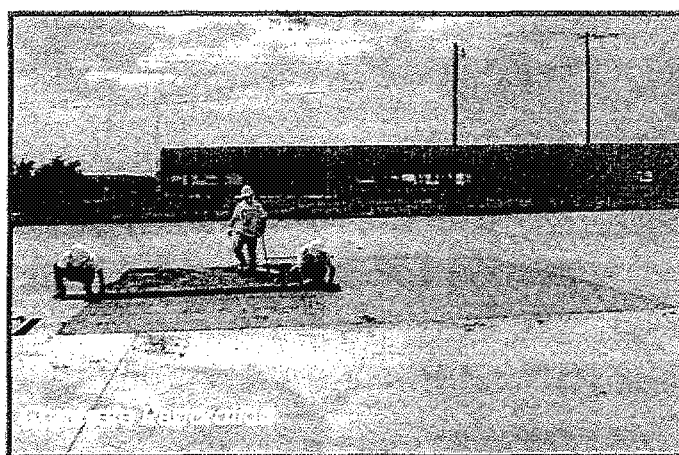
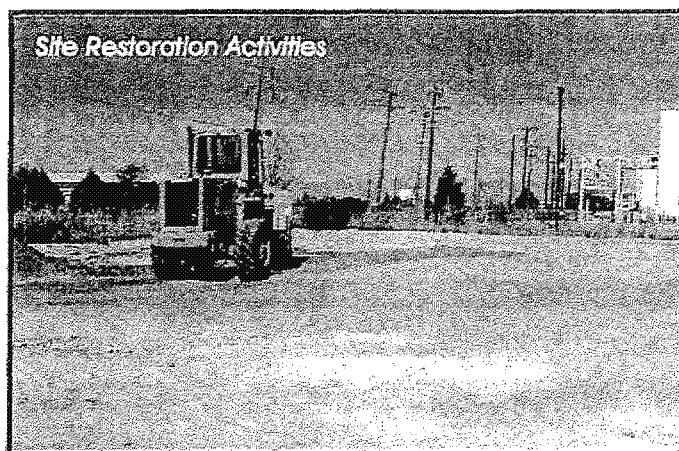
Approximately 35 cubic yards of soil required stabilization prior to off-site non-hazardous disposal. Again, all material was disposed of at BFI's Subtitle D facility in Itasca, Texas. Concrete debris was recycled at Big City Concrete in Dallas, Texas.

Following soil excavation, verification samples were collected from the excavation pits walls and floors. All results verified that the 300 mg/kg clean-up objectives had been achieved.

Finally, all pits were filled with sand, wire meshed, and then capped with concrete. All concrete fill was leveled to meet existing surrounding grade.

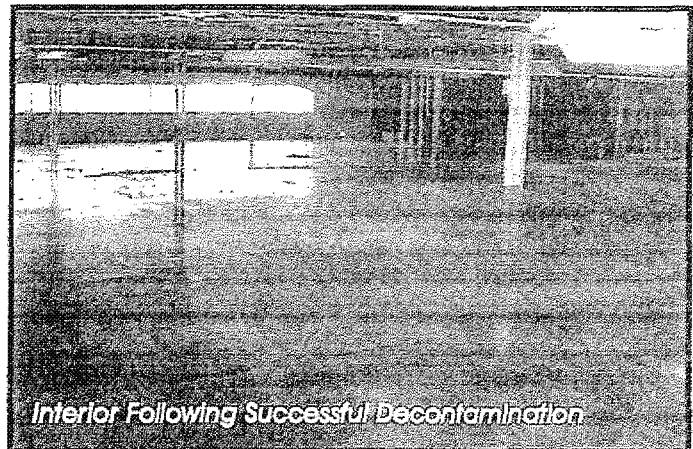
Interior Following Successful Decontamination

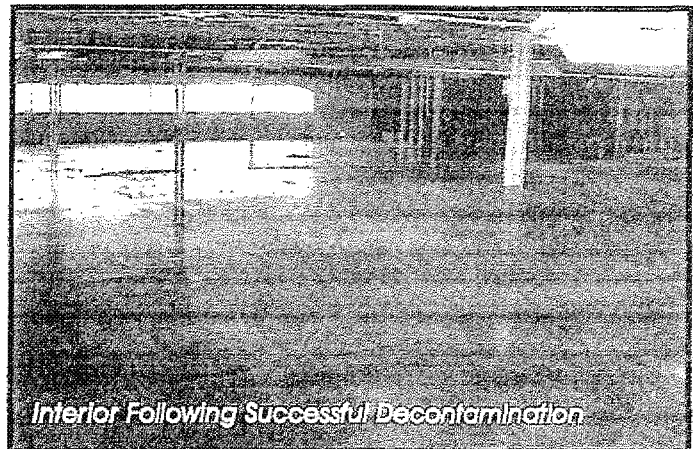
Interior Following Successful Decontamination

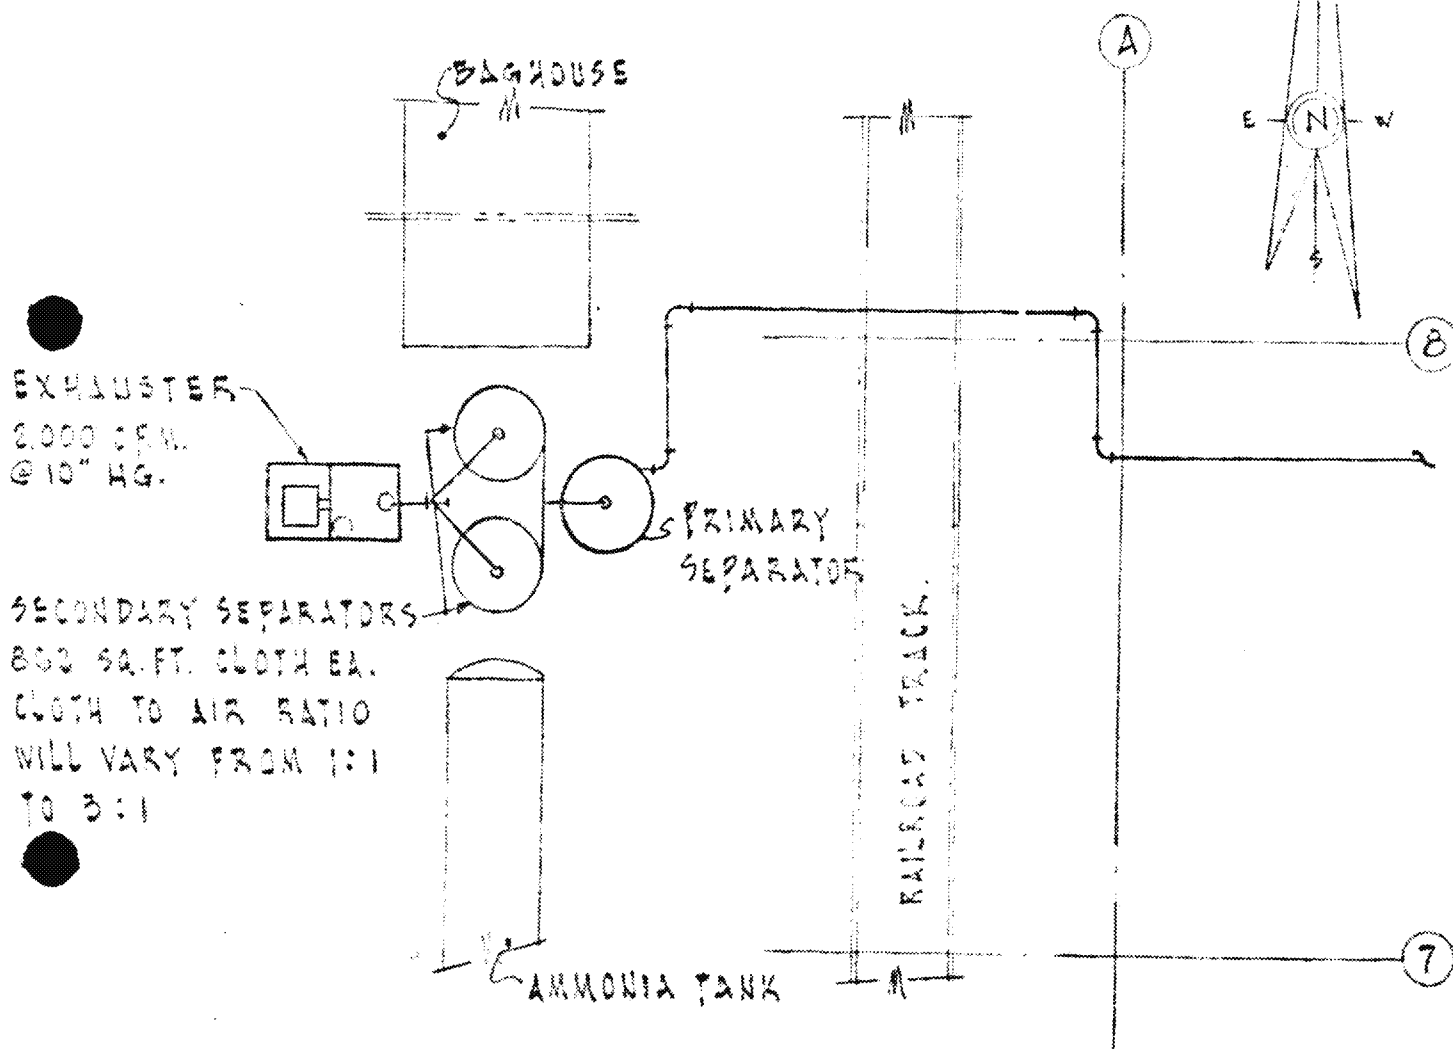
DALLAS VACUUM SYSTEM.

8"Ø VACUUM TUBING TO PLANT
APPROXIMATELY 25 VACUUM PICK-UP
POINTS THROUGHOUT THE PLANT

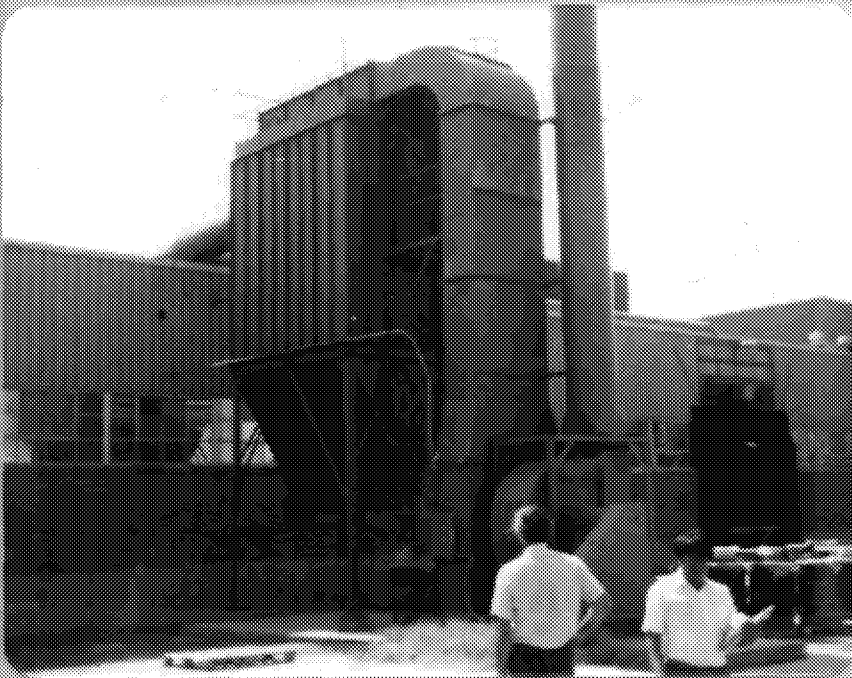
#9

Comments: BAG HOUSE AREA

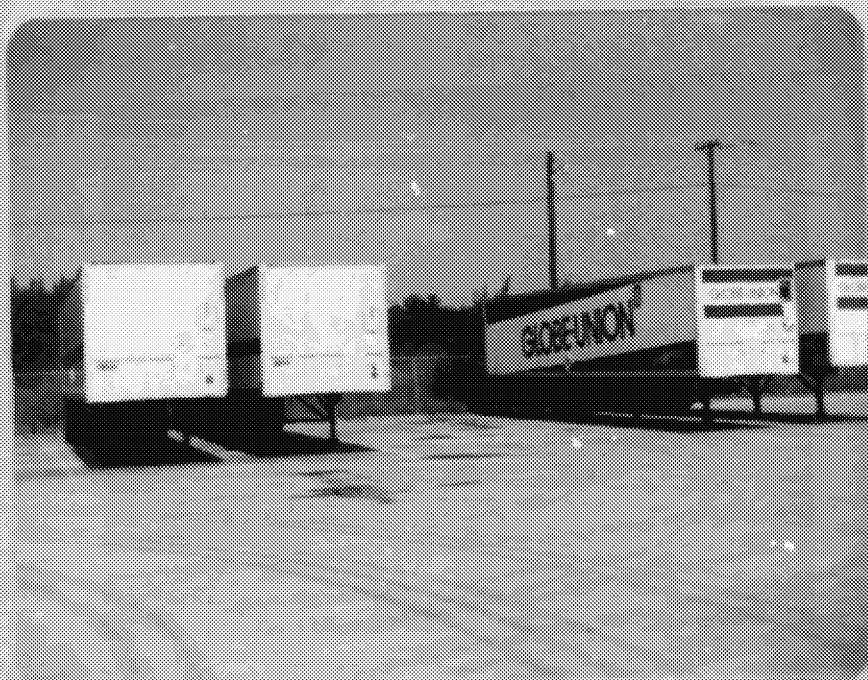
#11

Comments: LOADING-UNLOADING
AREA. (CONCRETE SURFACE)

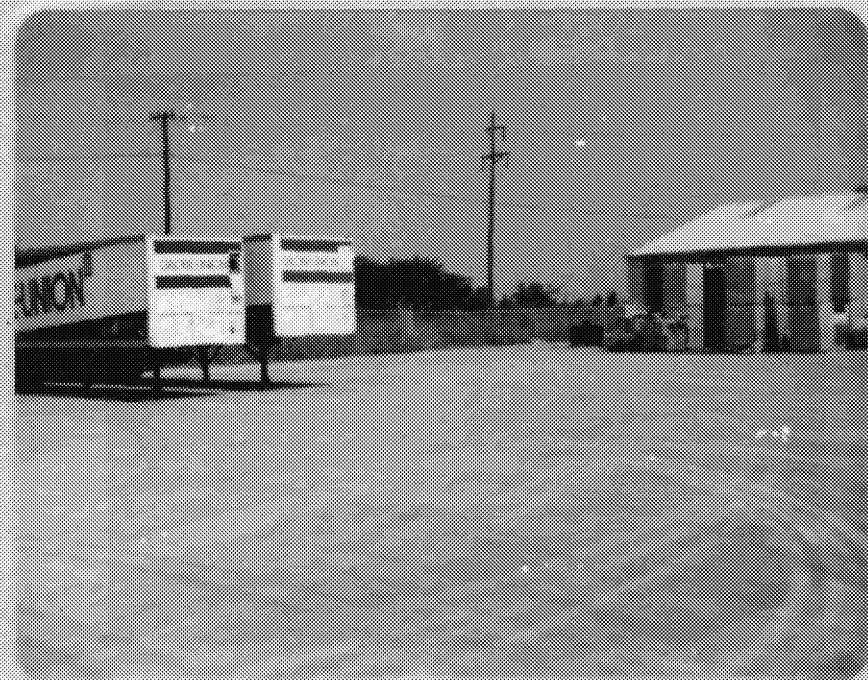
#12

Comments: LOADING-UNLOADING
AREA. (CONCRETE SURFACE)

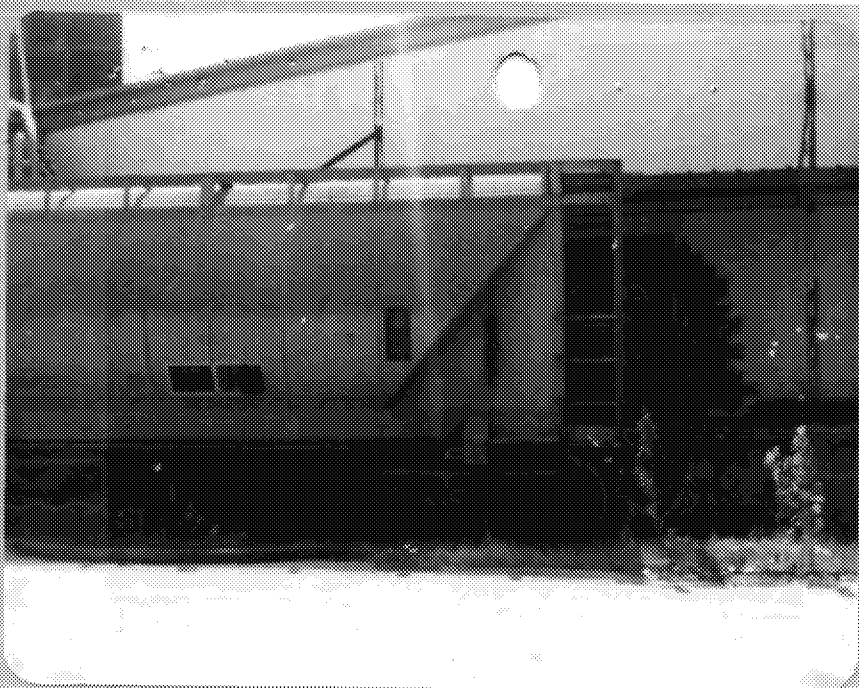
#13

Comments: LOADING-UNLOADING
AREA. (CONCRETE SURFACE)

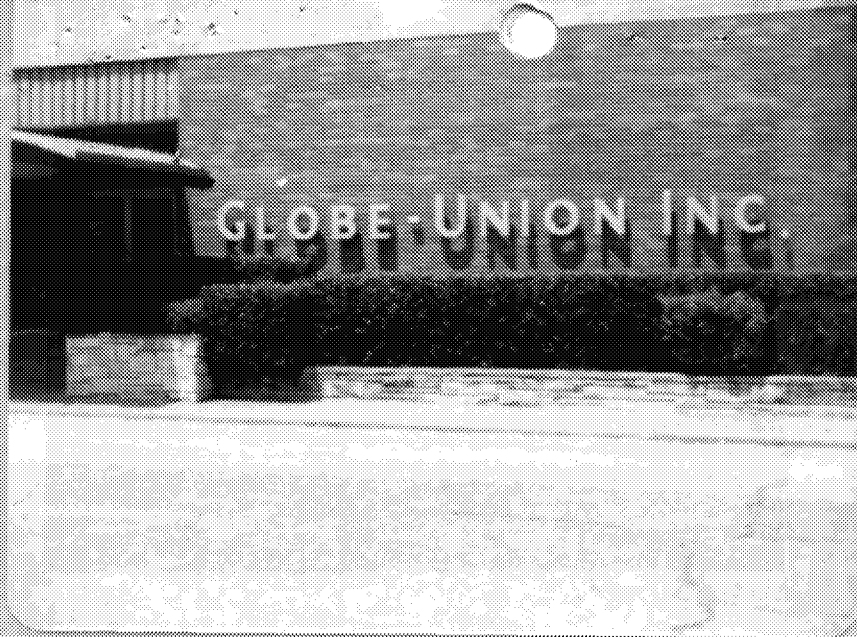
#15

SMALL CRACKS ON CONCRETE FLOOR
